MRL-TN-501

DEFECT INVESTIGATION OF CARTRIDGE ILLUMINATING 1-1/2 INCH

APRIL, 1986

TECHNICAL NOTE

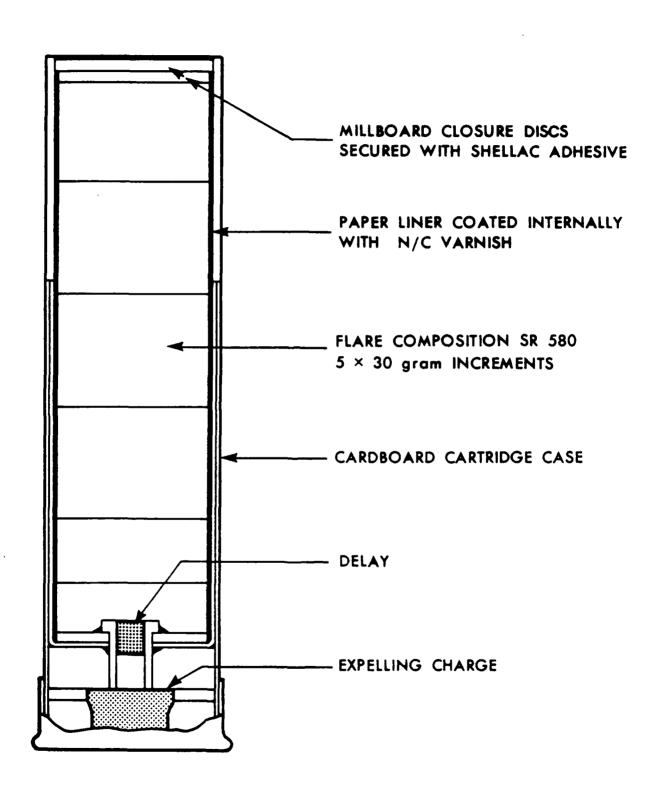
FIGURE 1 Cartridge Illuminating 1-1/2 inch J Mark 4T

The cartridge illuminating 1-1/2 inch J.Mark 4T (Fig. 1) contains pressed pellets of the flare composition SR 580 which was developed in 1937 at the Royal Armament Research and Development Establishment, Fort Halstead, The composition contains 60 per cent magnesium powder, grade 4; 36 per cent sodium nitrate and 4 per cent acaroid resin. In order to reduce attack of the magnesium by moisture, the metal powder is coated with the resin from alcoholic solution, dried and then mixed with the oxidizer. The loose composition is pressed into a paper cylinder, the base of which is pre-coated with nitrocellulose varnish. The cartridge case is made of cardboard which is closed, after loading, with a millboard disc and shellac adhesive. cartridges were manufactured at the Royal Ordnance Factory, Chorley, UK and have a recommended service life of five years from date of manufacture, subject to subsequent routine periodic inspection and proof. The cartridges are currently in service with the Royal Australian Navy and are normally stored in M19A1, and M2A1 boxes in lots of 10 and 20 respectively (Fig. 2). The free space in the boxes is packed with waxed paper to protect against vibration and rough handling. Both types of box incorporate a rubber gas seal in the lid.
